Issue 41

Winter 2001/2002

CONSIDERATIONS WHEN PAVING TREATED TIMBER BRIDGE DECKS

PROVO RIVER PEDESTRIAN COVERED BRIDGE, Wasatch County, Utah

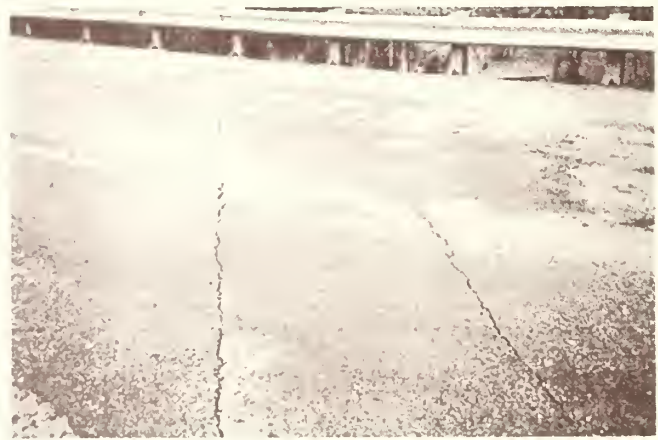
Figure 1. Pavement cracking caused by differential deflection of panels.

Glued-laminated timber panel decks have the highest incidence of asphalt paving problems resulting from structural factors. Unless mechanically interconnected, wheel loads will cause the glued-laminated deck panels to move independently of each other. If this displacement is large enough, it will result in reflective cracking of the asphalt pavement. In addition, drying shrinkage can open gaps at the deck panel interfaces, which can cause excessive asphalt pavement cracking.

Asphalt paving is flexible enough that uniform bridge superstructure deflection seldom causes pavement problems. The most common cause of pavement failure in glued-laminated panel deck systems is differential deflections between adjoining deck panels. This is particularly true of transverse glued-laminated deck panel systems (the panels are installed with the laminations perpendicular to traffic flow). Wheel loads moving from panel to panel cause rapid, repetitive panel movement. When these deflections are greater than .05 inches the pavement will usually crack. When deflections exceed .10 inches the cracks will often ravel, causing impact loadings and increased moisture penetration and retention.

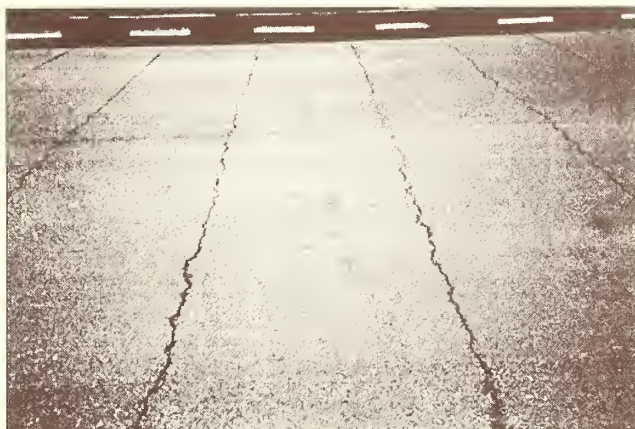
Figure 3. Pavement cracking caused by shrinkage of deck panels.

Glued-laminated deck panels are normally treated with oil-borne preservative treatments, thereby minimizing moisture penetration and the associated volume change. However, if deck panels are treated with waterborne treatments, or light oil solvent treatments in low humidity states, drying can cause enough deck shrinkage to crack asphalt paving at the panel joints. Deck panel expansion seldom causes pavement damage, but shrinkage of .125 inches per panel joint is enough to cause crack formation. A reduction in moisture content of as little as 3 percent can cause .375 inches of shrinkage in a 4-foot wide glued-laminated deck panel [4].

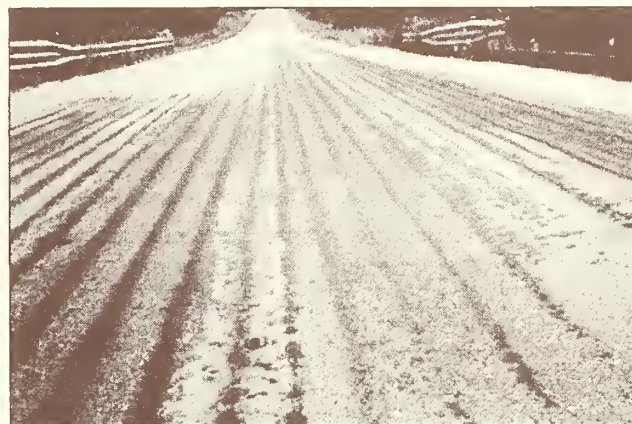
Figure 4. Bleeding caused by over treatment (note tracking from bridge to approach).

Michigan [7]. Two of these bridges had undergone post treatment procedures as required by the BMPs. The other two bridges had not. Core samples revealed similar creosote retentions in all four bridges. The two bridges not receiving post treatment procedures exhibited excessive underside leakage of creosote, bleeding of asphalt/creosote on the roadway surface, and pavement rutting. The two bridges receiving a post treatment cleaning procedure had none of these problems.

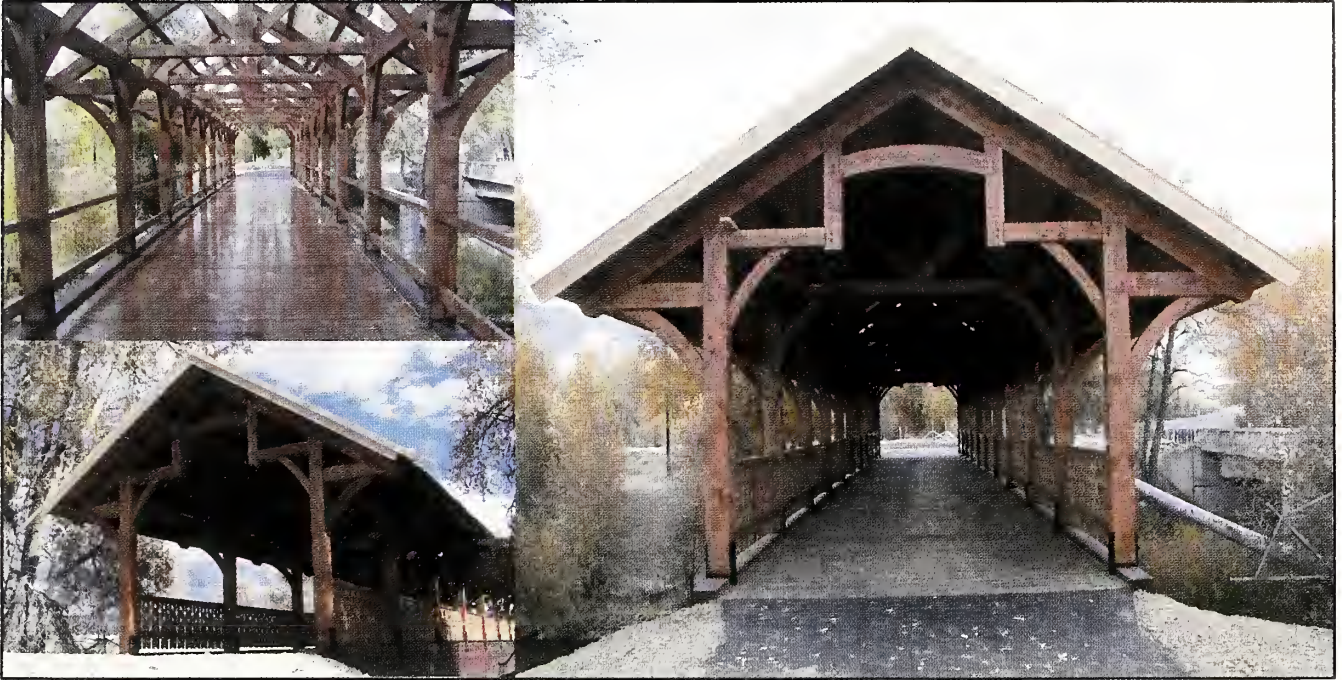
Type: Covered pedestrian bridge with glued-laminated/fiber reinforced polymer wood beams and transverse glued-laminated deck

Bridge length: 125'-1" (2 spans)

Material: Glued-laminated wood
 Species: Coastal Douglas-fir
 Size: 3'-8" x 48" x 12'-0" panels
 Preservative treatment: Pentachlorophenol in light oil

Material: Glued-laminated wood
 Species: Coastal Douglas-fir
 Sizes: Interior - 6-3/4" x 42";
 Exterior - 8-3/4" x 54" fiber reinforced with Kevlar
 Preservative treatment: Pentachlorophenol in light oil

Helical screw pile abutments
 Glued-laminated abutment caps
 Reinforced concrete pier supported by helical screw piles
